**VISUAL SITE INSPECTION REPORT - 2017**

SOUTHERN INDIANA GAS AND ELECTRIC  
A. B. BROWN GENERATING STATION  
TYPE III RESTRICTED WASTE LANDFILL  
WEST FRANKLIN, IN

ATC PROJECT NO. 170LF00430

DECEMBER 18, 2017

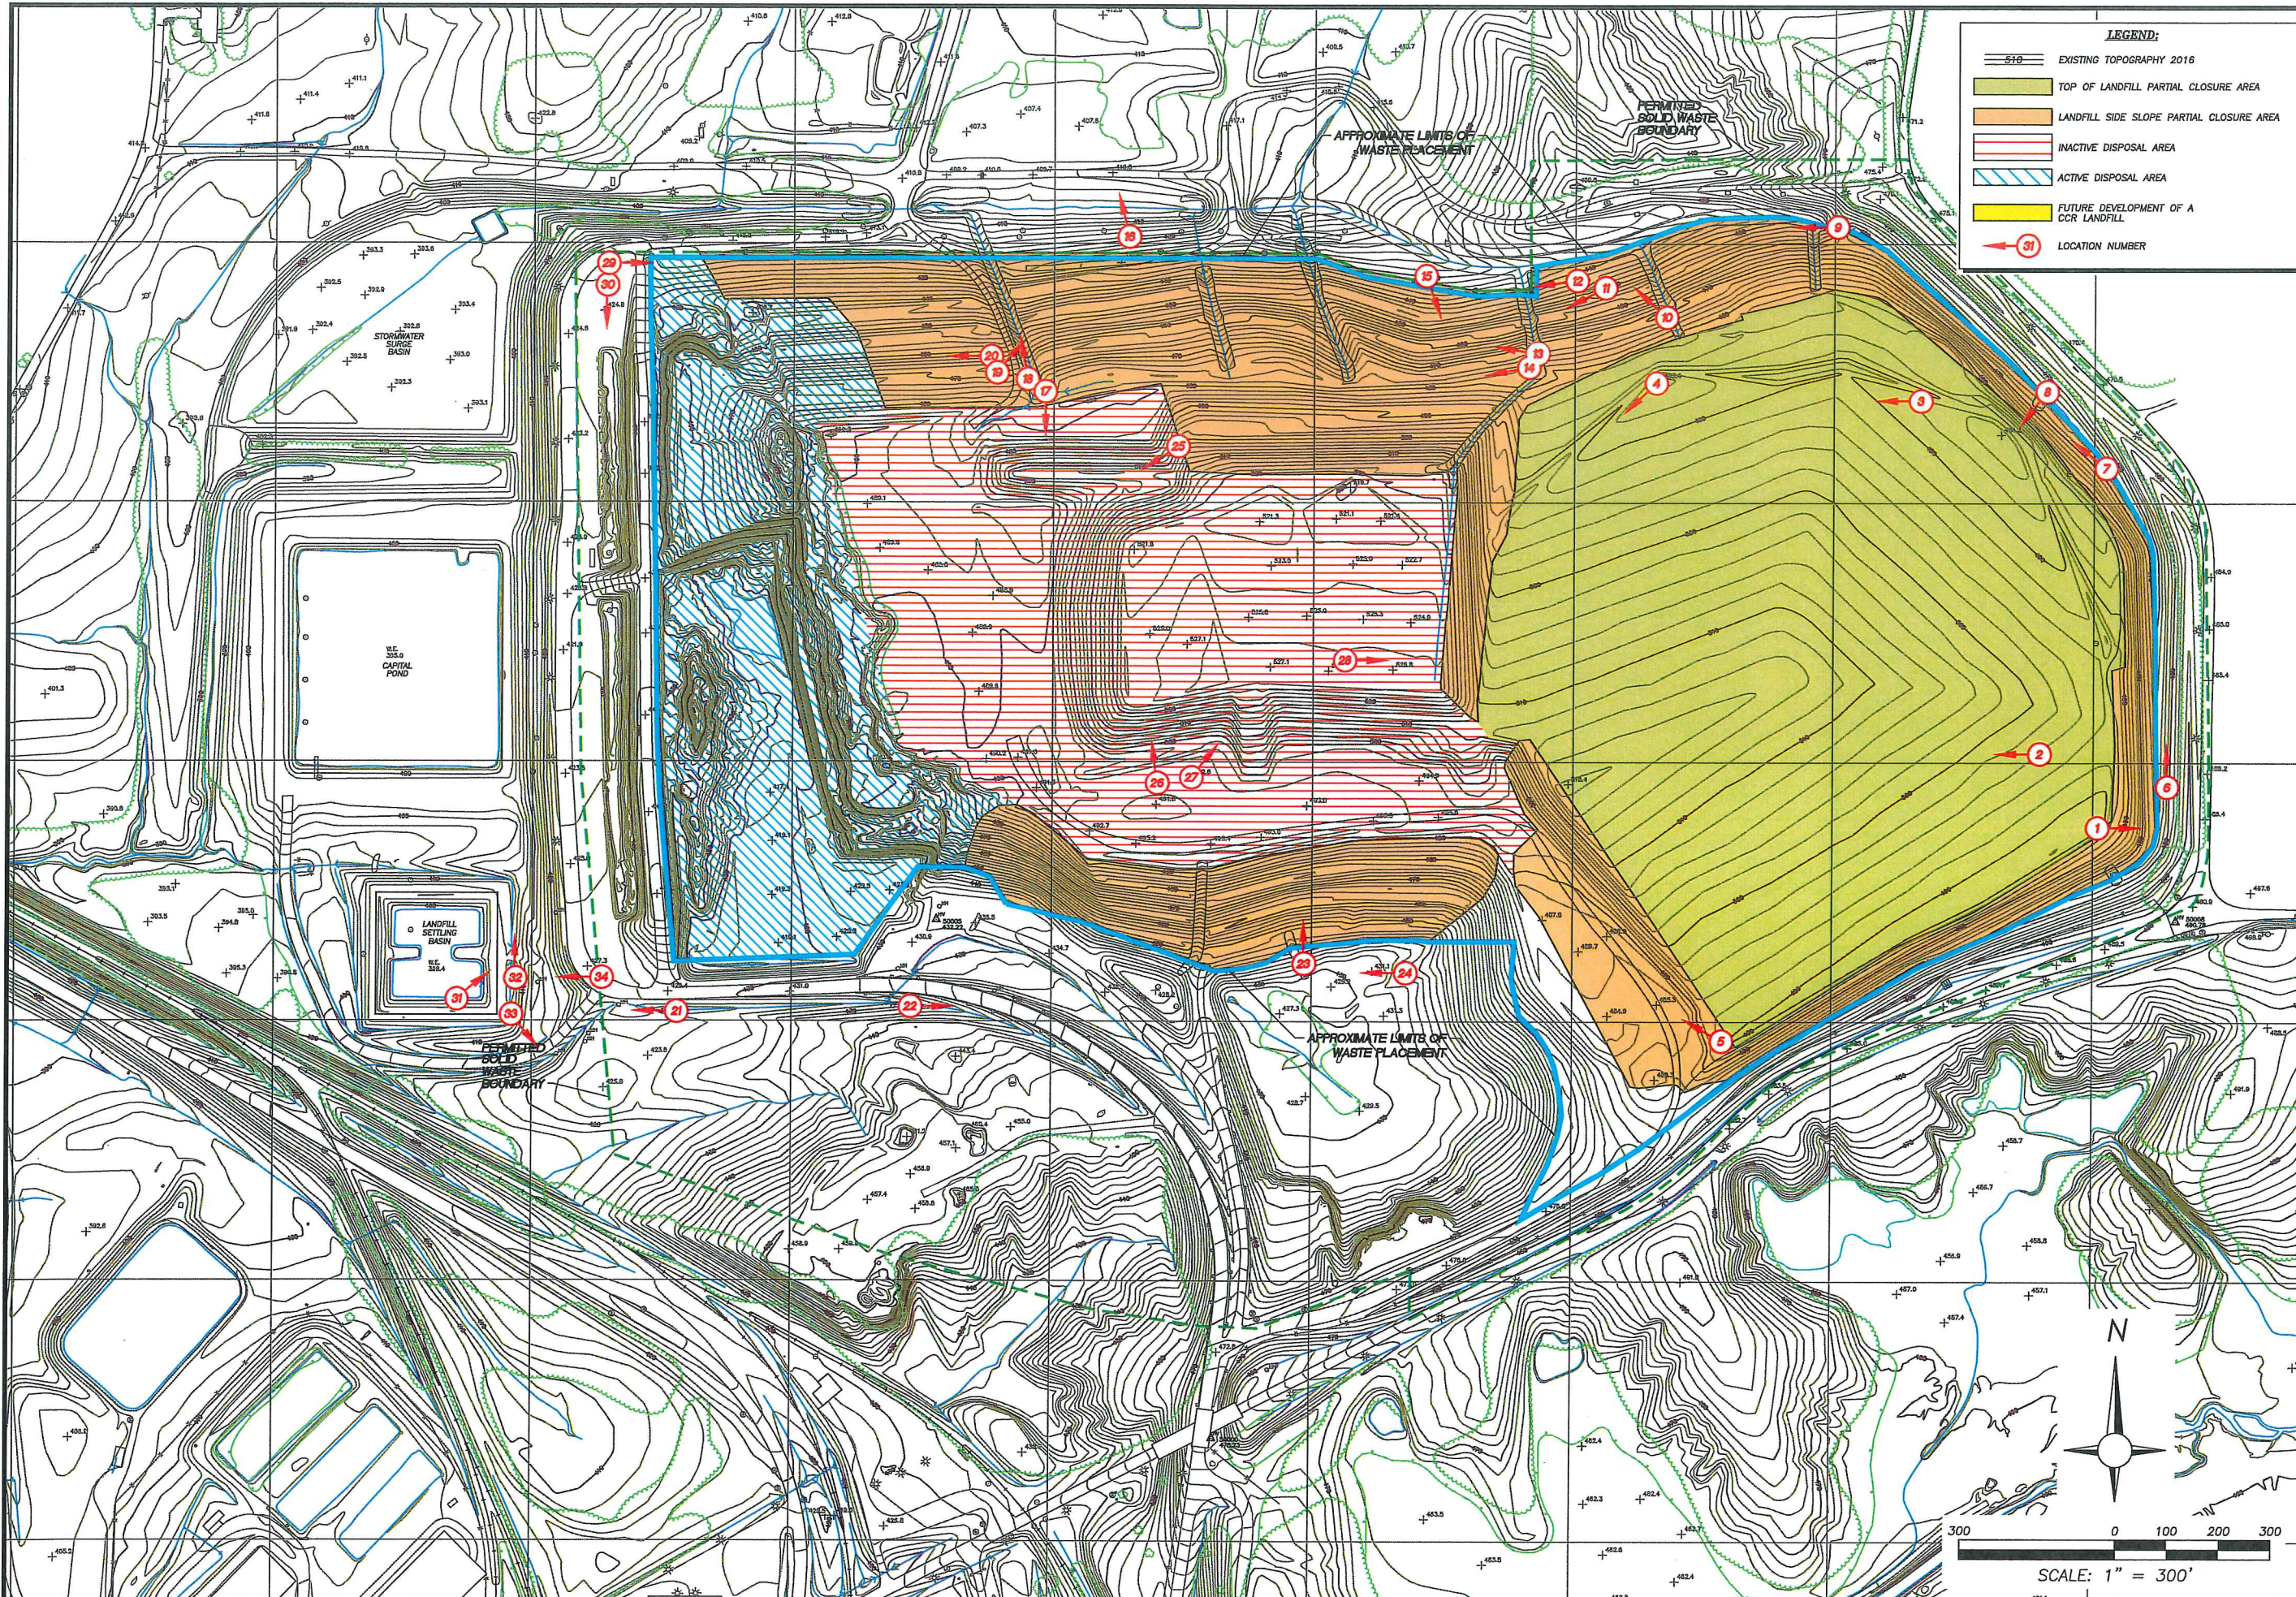
Project Number: 170LF00430	Dwn. By: CR	Drawing File: SEE LEFT	Ckd. By: CD	App'd By: 	Ckd. Date:
<b>2017 INSPECTION SITE PLAN</b> TYPE III RESTRICTED WASTE LANDFILL A.B. BROWN GENERATING STATION					
Date: 12/17					
Scale: AS SHOWN					
Figure: 1

- 2) Several surface depressions/erosion features have formed in areas adjacent to riprap downchute channels, along the flow line of diversion berms and alongside downdrain pipes (Locations 8 and 10). One such erosion feature, adjacent to a riprap downchute channel, located on the north side of the landfill, west of the north-south haul road on the backside of the upper level berm (Location 19) is approximately 8-feet long, 2-feet wide, and 1-foot deep. An additional erosion feature is located alongside one outlet pipe drainage structure near the base of the landfill in the vicinity of the perimeter ditch on the east side of the landfill.

- 3) The perimeter ditch on the south and east sides of the east partial closure area is generally well vegetated. Some areas along the ditch do, however, have standing water where equipment has left shallow depressions from track marks. (Location 7).

- 4) The downdrain pipes and the riprap lined downchutes on the north side of the landfill are generally in good condition. The outlet area at the top of one of the riprap downchute channels has formed erosion gullies just downstream of the culvert inverts. (Location 17).

- 5) A seep is present on the north slope near the east end of the landfill. A trench has been excavated in the area to collect the seep water and convey it in pipes to the Capital Pond. It is our understanding that the flow rate varies seasonally and that the peak rate continues to decrease following the construction of the composite final cover across the top of the east end of the landfill. Early in the fall of 2016 a hay bale diversion berm was replaced upstream of the trench to divert potential overland runoff from intermingling with seep waters. It appears that a straw waddle has also been added to divert stormwater from the trench.

- 6) A toe drain pipe near Riser Pipe #5, located on the north edge of the landfill, adjacent to the perimeter ditch, has salt deposits on the exterior of the pipe and around its base (Location 15). Additionally, some salts were noted along the north side of Manhole #10. Neither area appeared to be blocked at the time of inspection however these salts indicate past blockage in the pipes. According to visual inspection, water levels appeared to be normal inside manholes, so blockage at the time of inspection is unlikely. The facility has recently installed additional manholes and lines to alleviate potential blockages that may be associated with the toe drain lines. Additionally, a controlled chemical flush and vac procedure was performed in the summer of 2017 to clear lines.

- 7) There are seeps discharging from the south slope that collect in the valley (bowl) area. This includes seeps noted within one of the riprap lined downchutes. The combined flow rate at the time of this visual inspection was estimated to be approximately 1 gpm. The toe of slope is generally wet and covered with phragmites with isolated areas of standing water (Location 23).

- 9) There are salt deposits in the perimeter ditch located south of the landfill and the inlet to the culvert of the drainage ditch is nearly totally blocked with sediment (Locations 21 and 22). At the time of the inspection these salt deposits were discussed with facility personnel and were determined to be the likely result of runoff from the haul road.

- 2) At the northwest corner of Cell 18 at the edge of the haul road, the water surface of the standing water in the cell is only slightly below road elevation indicating a small amount of freeboard (Location 29). During large magnitude storm events the cell may become more susceptible to overtopping.

- 1.) The upstream slopes of the sediment pond were lined with riprap and appeared in satisfactory condition (Locations 31 & 34). However, soil erosion has occurred on the east bank of the pond above the inlet pipe.

- 3.) As noted in the landfill sideslope partial closure area, salt deposits were noted in the ditch along the east and north banks of the pond near the manhole upstream from the sediment basin inlet pipe (Location 32) and also downstream of the green culvert pipe located at the southeast corner of the Sedimentation Basin (Location 33). It appears that the salt deposits are associated with surface water runoff from the landfill haul road.

**Recommendation: Fill depressions and erosion gullies. Either revegetate or apply additional riprap as needed. Where needed, divert water around the erosion area to prevent continued erosion. Monitor the repaired areas for the redevelopment of the erosion.**

**Recommendation: Fill depressions along the ditch to prevent standing water accumulation in the ditch.**

**Recommendation: Fill and line the outlet area with gravel or erosion control mat to prevent erosion at the outlets.**

**Recommendation: Continue to collect and convey the seep water by discharging to the Capital Pond.**

**Recommendation: Continue a regular maintenance program on the toe drain lines to minimize the potential for development of blockages.**

**Recommendation: Continue to collect water discharging from the seeps and route to the Capitol Pond through the Sedimentation Basin. Monitor the area between the south side of the Vertical Expansion Area and the north slope of the bowl area to prevent the ponding of surface water which could be a source of water for the seeps. .**

**Recommendation: Continue to implement good engineering controls for haul trucks to prevent spilling of CCR material onto perimeter roadways and ditches. Evaluate options to redirect haul road runoff to direct water back to the truck pit or other methods of routing water to the lined sediment basin.**

**Recommendation: Maintain a low normal pool elevation inside the cell collection area and continue to monitor elevation rise during storm events. Consider additional drainage from inside the cell or the addition of a soil berm to increase freeboard in this area as needed.**

**Recommendation: Place erosion control or stormwater diversion above the riprap slope to prevent soil erosion into the pond. Overseed recent areas of disturbance along the east overbank below the haul road.**

**Recommendation: Modify the drainage ditch located on the south side of the haul road to discharge to the lined sediment basin.**
