VISUAL SITE INSPECTION REPORT – 2022

SOUTHERN INDIANA GAS AND ELECTRIC
A.B. BROWN GENERATING STATION
TYPE III RESTRICTED WASTE LANDFILL
WEST FRANKLIN, IN

ATLAS PROJECT NO. 170LF01372

JANUARY 6, 2023

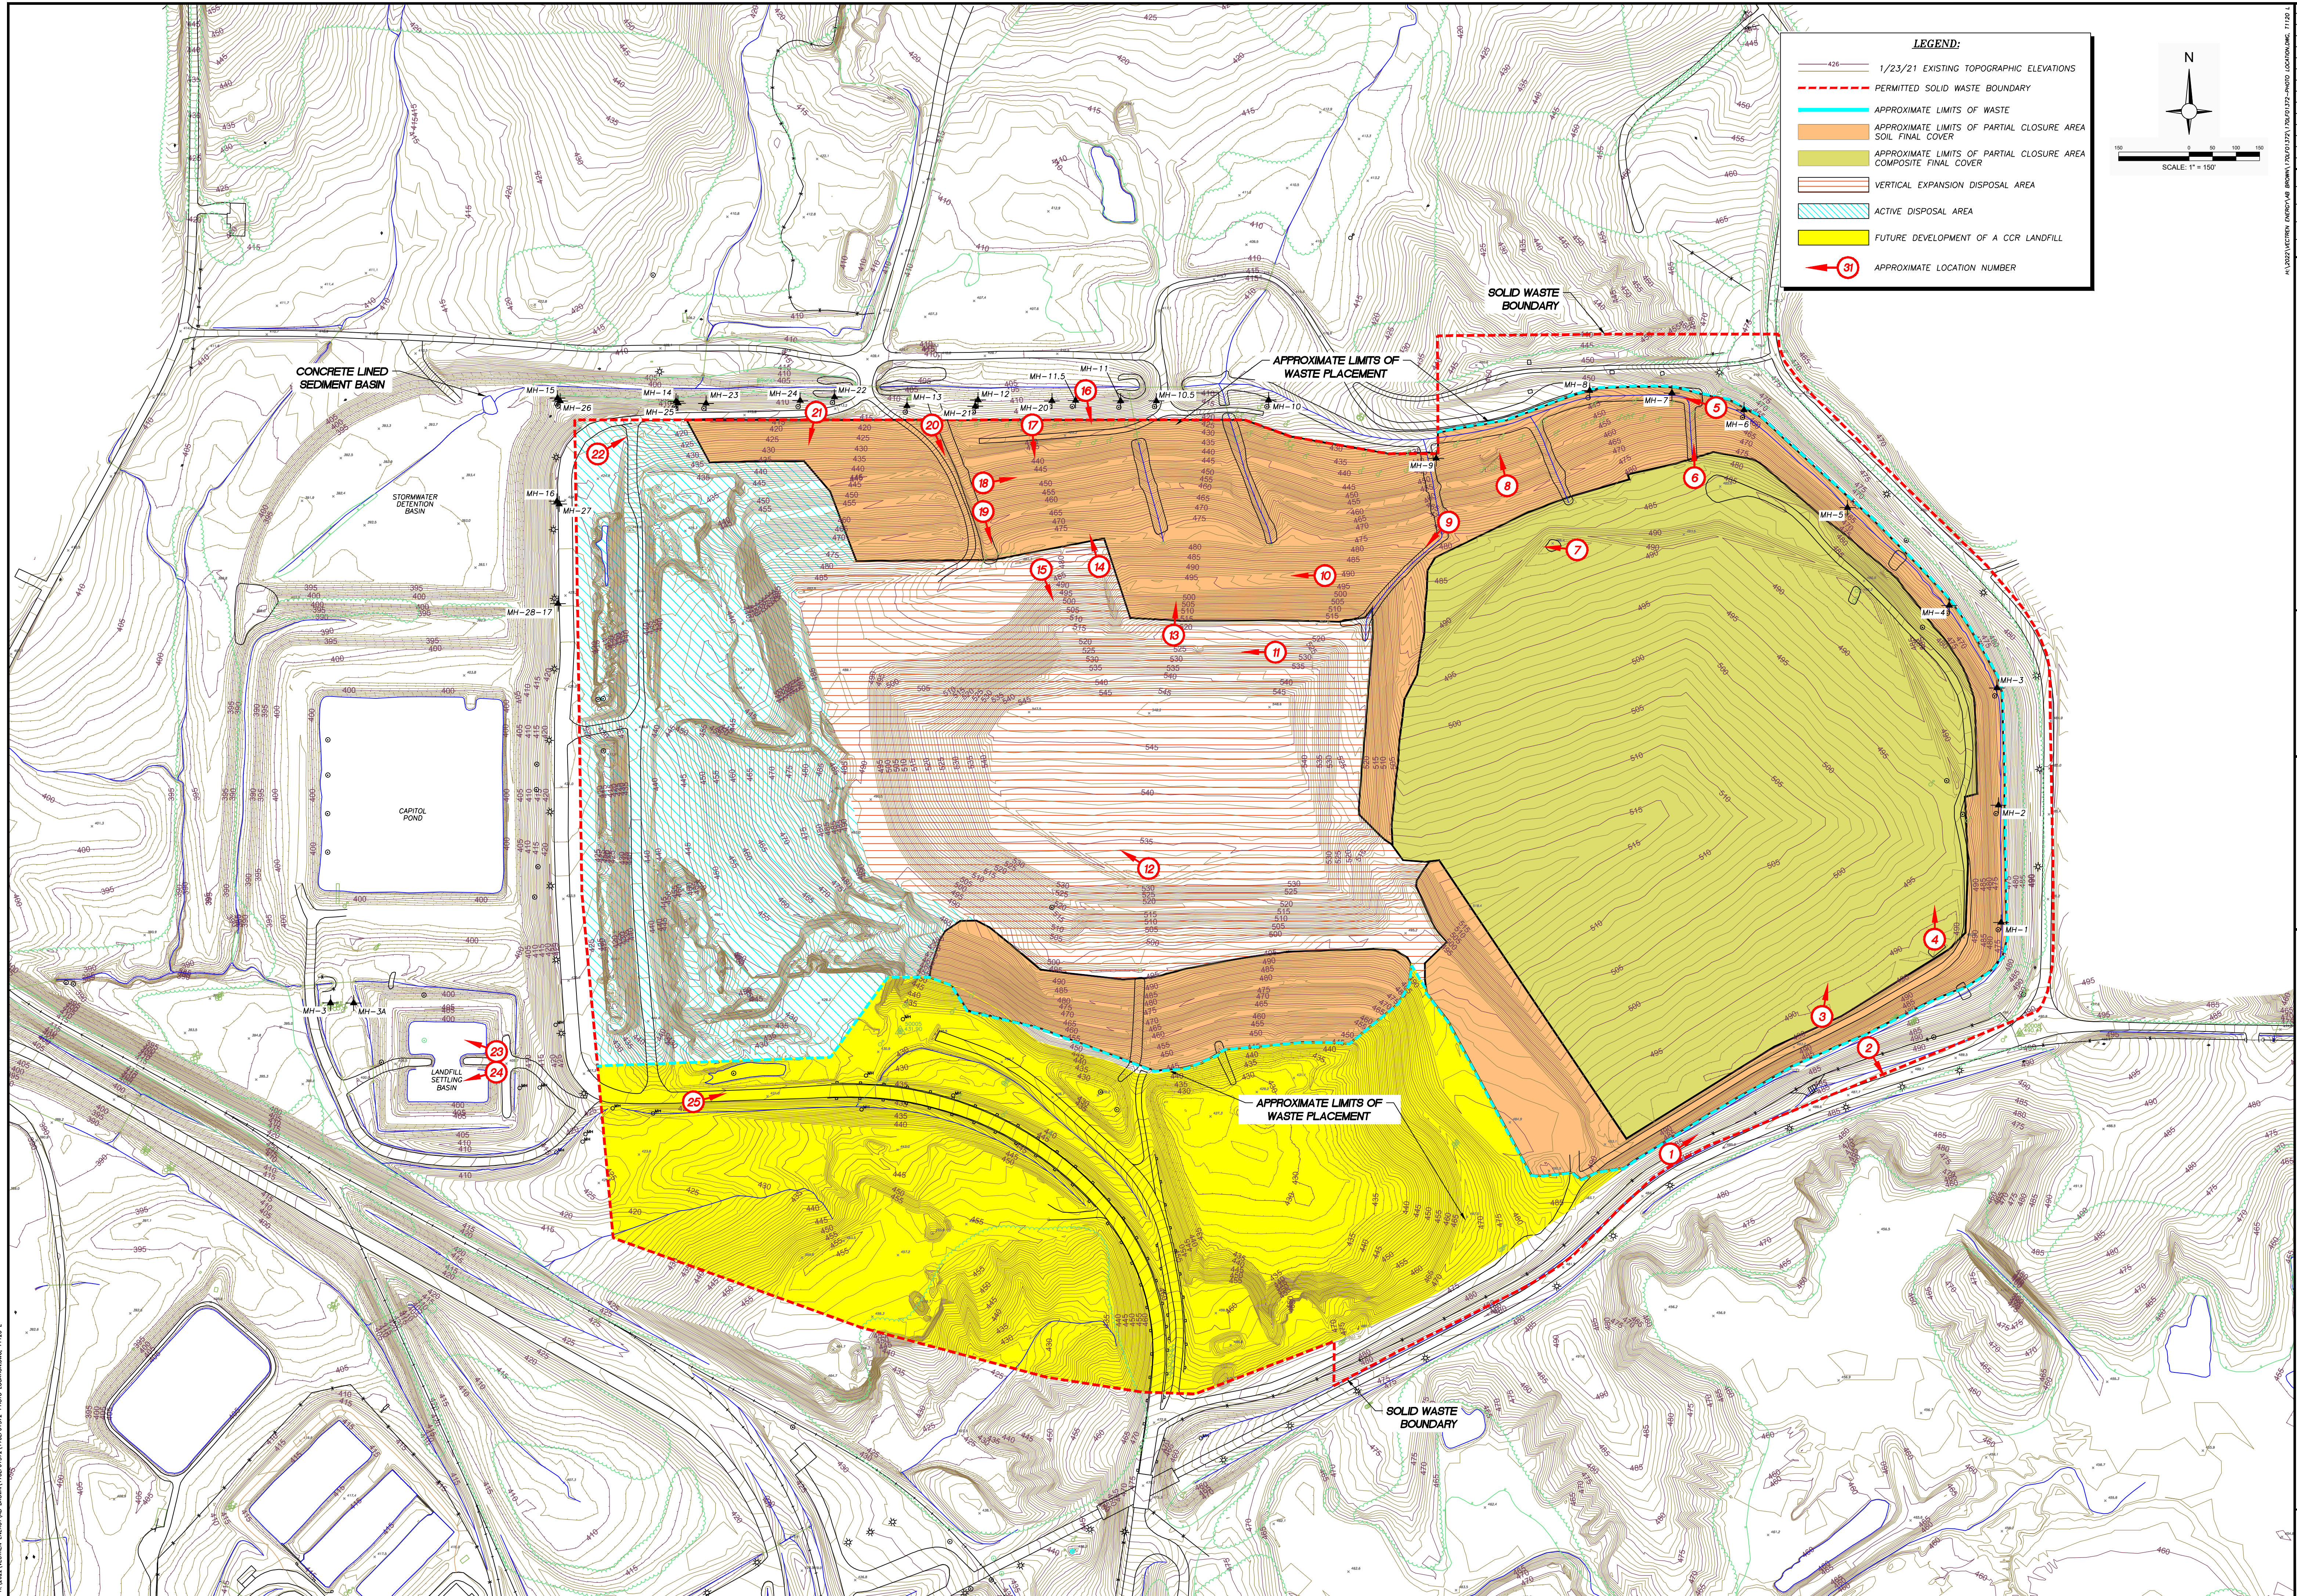
- 2) Observed sparse vegetation of the Final Cover (Locations 6, 17, 18, and 20).

- 3) Although most drop inlets were in good conditions (Location 4), a few isolated areas near some drop inlets exhibited excess vegetation growth and erosion at the time of the inspection (Locations 7).

- 4) Tall vegetation growth (relative to the adjacent grass) was observed along the edge of some drainage channels on the north side of the landfill and near an outlet drainage pipe, on the northeast side of the landfill (Locations 5, 9, 19 and 20). Site personnel clarified that the tall

- 7) Sediment accumulation was observed in a manhole of the north side of the landfill (Location 16).

- 2) A drop inlet on the north side of the Vertical Expansion Disposal Area exhibited a damaged trash rack at the time of the inspection (Location 11).

- 3) A drop inlet on the top of the Vertical Expansion Disposal Area lacks appropriate sediment controls (Location 12).

- 4) A drop inlet on the top of the Vertical Expansion Disposal Area exhibited erosion at the time of the inspection (Location 13).

- 5) Erosion rills have formed on the middle north slope of the Vertical Expansion Disposal Area (Location 14).

- 6) Sediment accumulation was observed at an outlet drainage pipe on the north side of the Vertical Expansion Disposal Area (Location 15).

The inspection conducted on December 21, 2022 did not reveal any signs of imminent failure for the landfill. However, there are isolated areas of erosion that require repair and/or modification as part of the ongoing maintenance of the landfill area.

There were no signs of structural weakness noted within the permitted solid waste boundary at the time of this visual inspection. Additional temporary erosion and sediment controls should be deployed in the Vertical Expansion Disposal Area.

Recommendation: Areas of sparse vegetation should be reseeded with similar grasses to the ones at the site, and temporarily isolated to prevent trampling and help re-establish grass cover.

Recommendation: Remove excess vegetation and repair erosion by establishing a new vegetation cover.

Recommendation: Continue planned vegetation maintenance.

Recommendation: Remove sediment accumulation inside the manhole.

Recommendation: Repair or replace the trash rack.

Recommendation: Improve sediment controls around drop inlet.

Recommendation: Repair the erosion and reseed as necessary.

Recommendation: Repair rills, install erosion control blankets and/or other erosion BMPs, and reseed areas to re-establish grass cover.

Recommendation: Remove sediment accumulation at the outlet of the drainage pipe.
