Submitted to
Southern Indiana
Gas & Electric Company
(SIGECO)
dba CenterPoint Energy
Indiana South
211 Northwest Riverside
Drive, Evansville, IN 47708

October 13, 2021

CCR Certification:
Structural Stability Assessment
§257.73 (d)
for the
Ash Pond
at the
A.B. Brown Generating Station
Revision 0

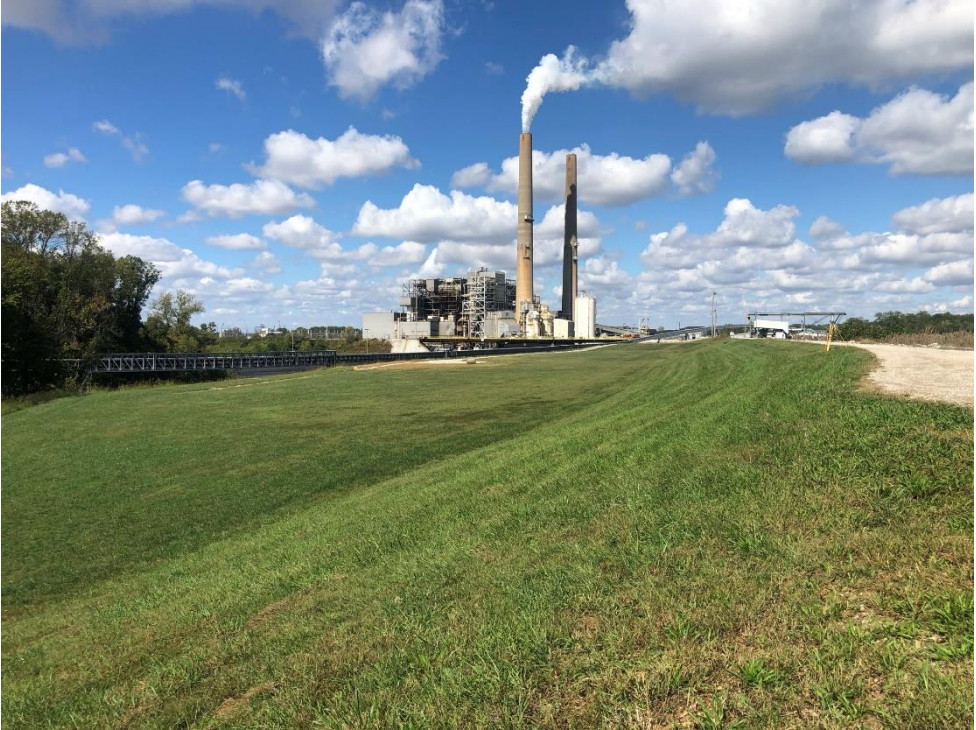
<p>Photo No. 1</p>	<p>Date: 10/08/2021</p>

<p>Location: A.B. Brown Generating Station</p>		
<p>Description: Standing at east end of dike, looking west.</p> <p>Picture shows slope protection on downslope of dike.</p> <p>Photographer: Trinity Webb</p>		
<p>Photo No. 2</p>	<p>Date: 10/08/2021</p>

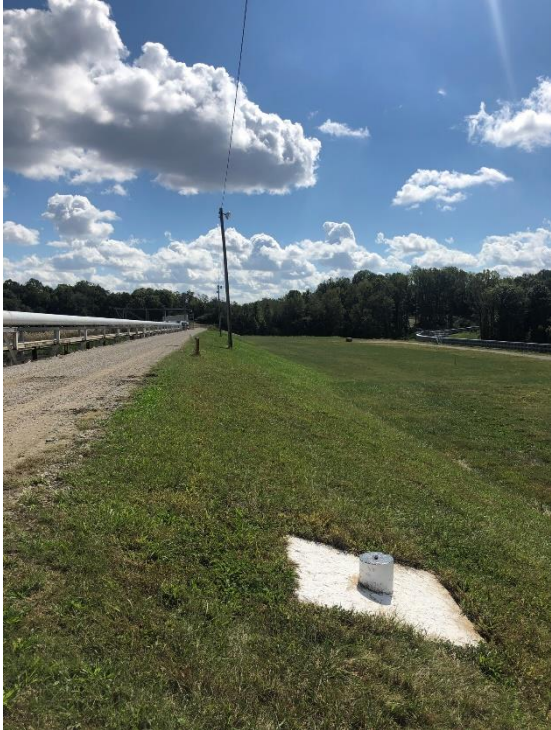
<p>Location: A.B. Brown Generating Station</p>		
<p>Description: Standing at west end of dike, looking east.</p> <p>Picture shows slope protection on downslope of dike.</p> <p>Photographer: Trinity Webb</p>

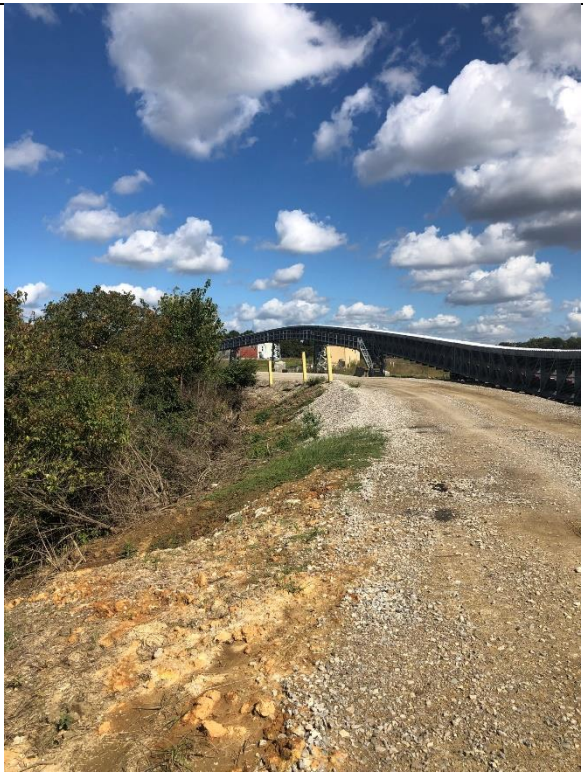
<p>Photo No. 3</p>	<p>Date: 10/08/2021</p>

<p>Location: A.B. Brown Generating Station</p>				
<p>Description: Standing on western leg of dike, looking north. Picture shows slope protection on exterior face of dike. Photographer: Trinity Webb</p>				
<p>Photo No. 4</p>	<p>Date: 10/08/2021</p>

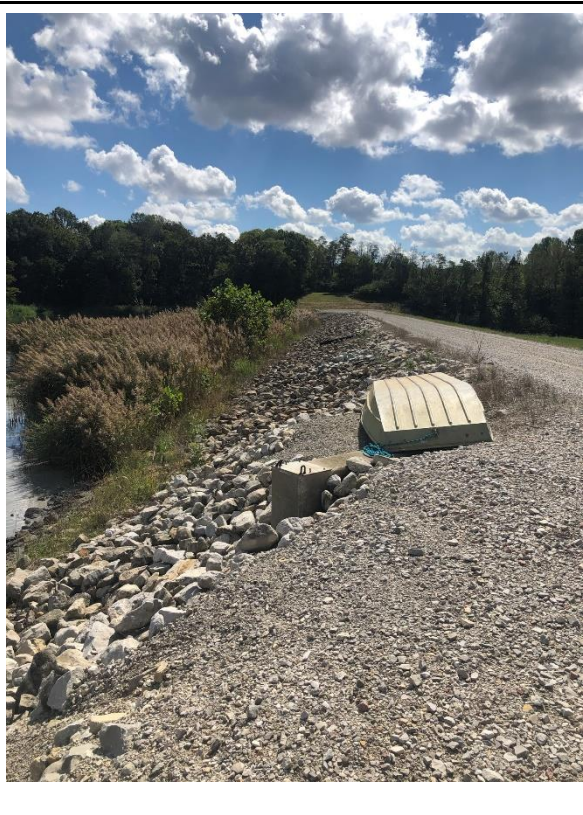
<p>Location: A.B. Brown Generating Station</p>				
<p>Description: Standing midway along southern dike, looking back over surface impoundment. Picture shows stability of dike into surface impoundment. Photographer: Trinity Webb</p>
